# **Kings Beach Watershed Improvement Project**

## **Final Hydrologic Conditions Report**

**February 2006**

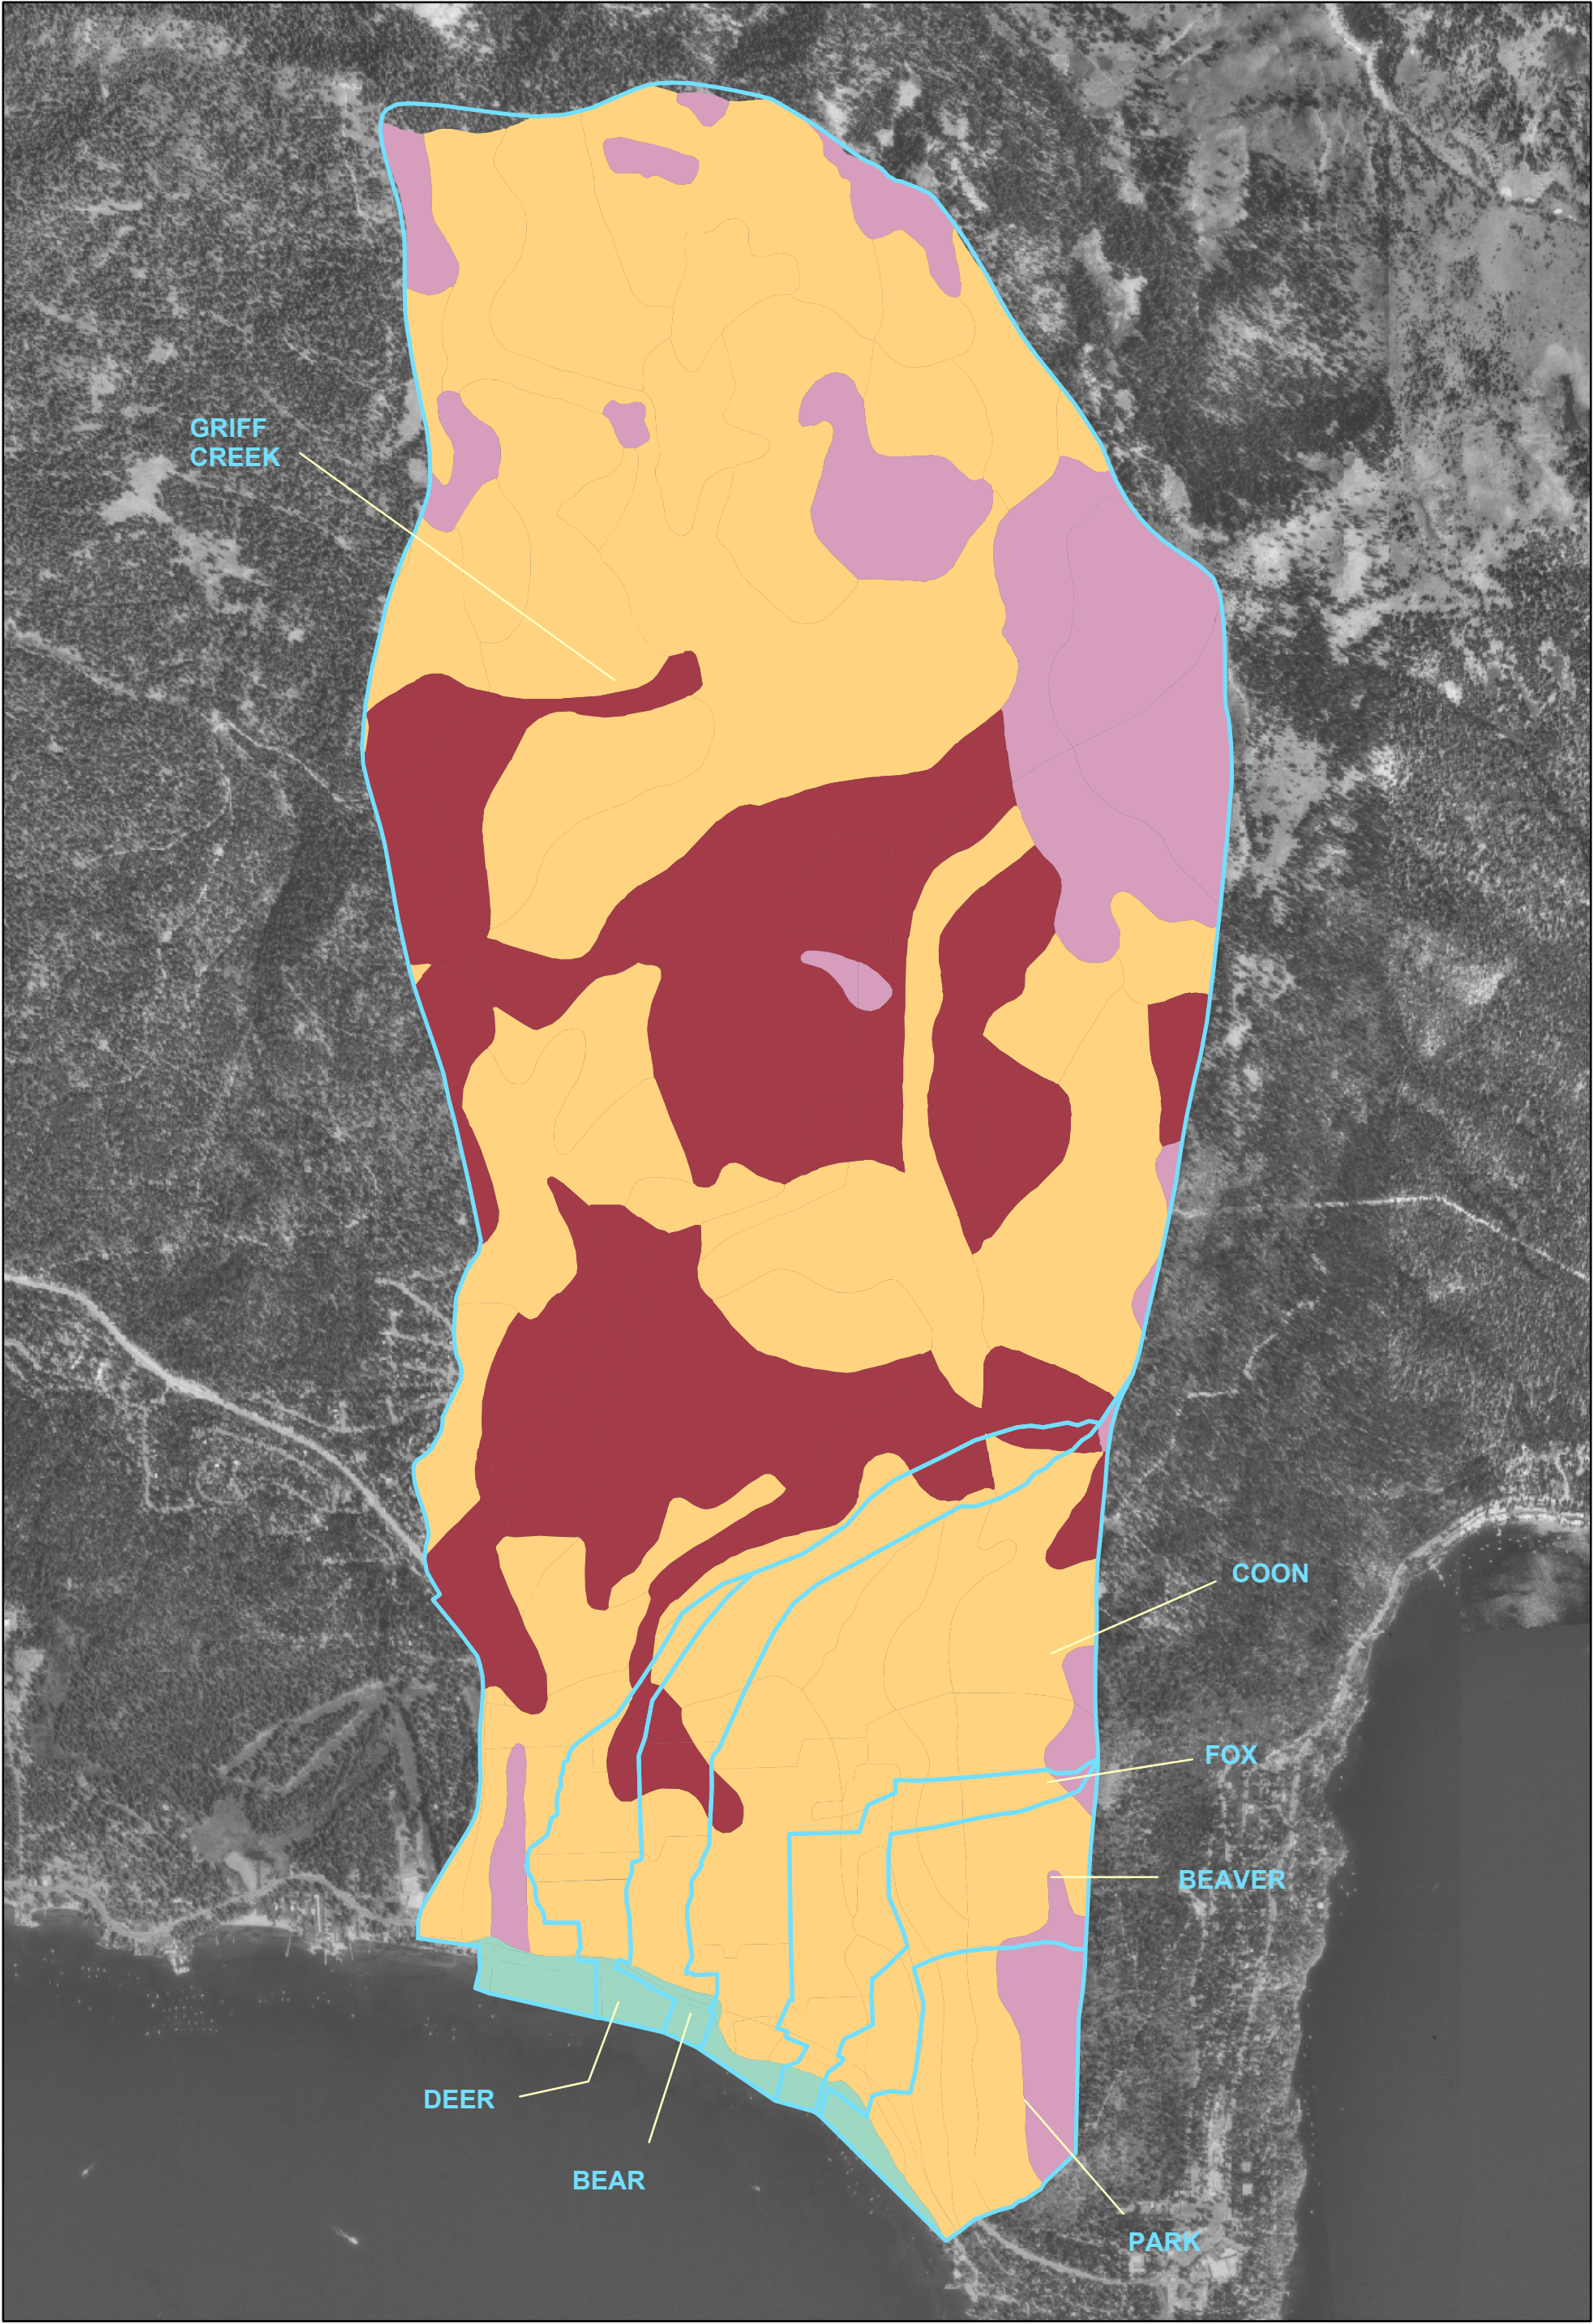
**Watershed Boundary**  
Secondary Watershed

**Hydro Class**  
A  
B  
C  
D
